NIST NCSTAR 1-5A

Federal Building and Fire Safety Investigation of the World Trade Center Disaster

Visual Evidence, Damage Estimates, And Timeline Analysis

(Chapter 9 - Appendix C)

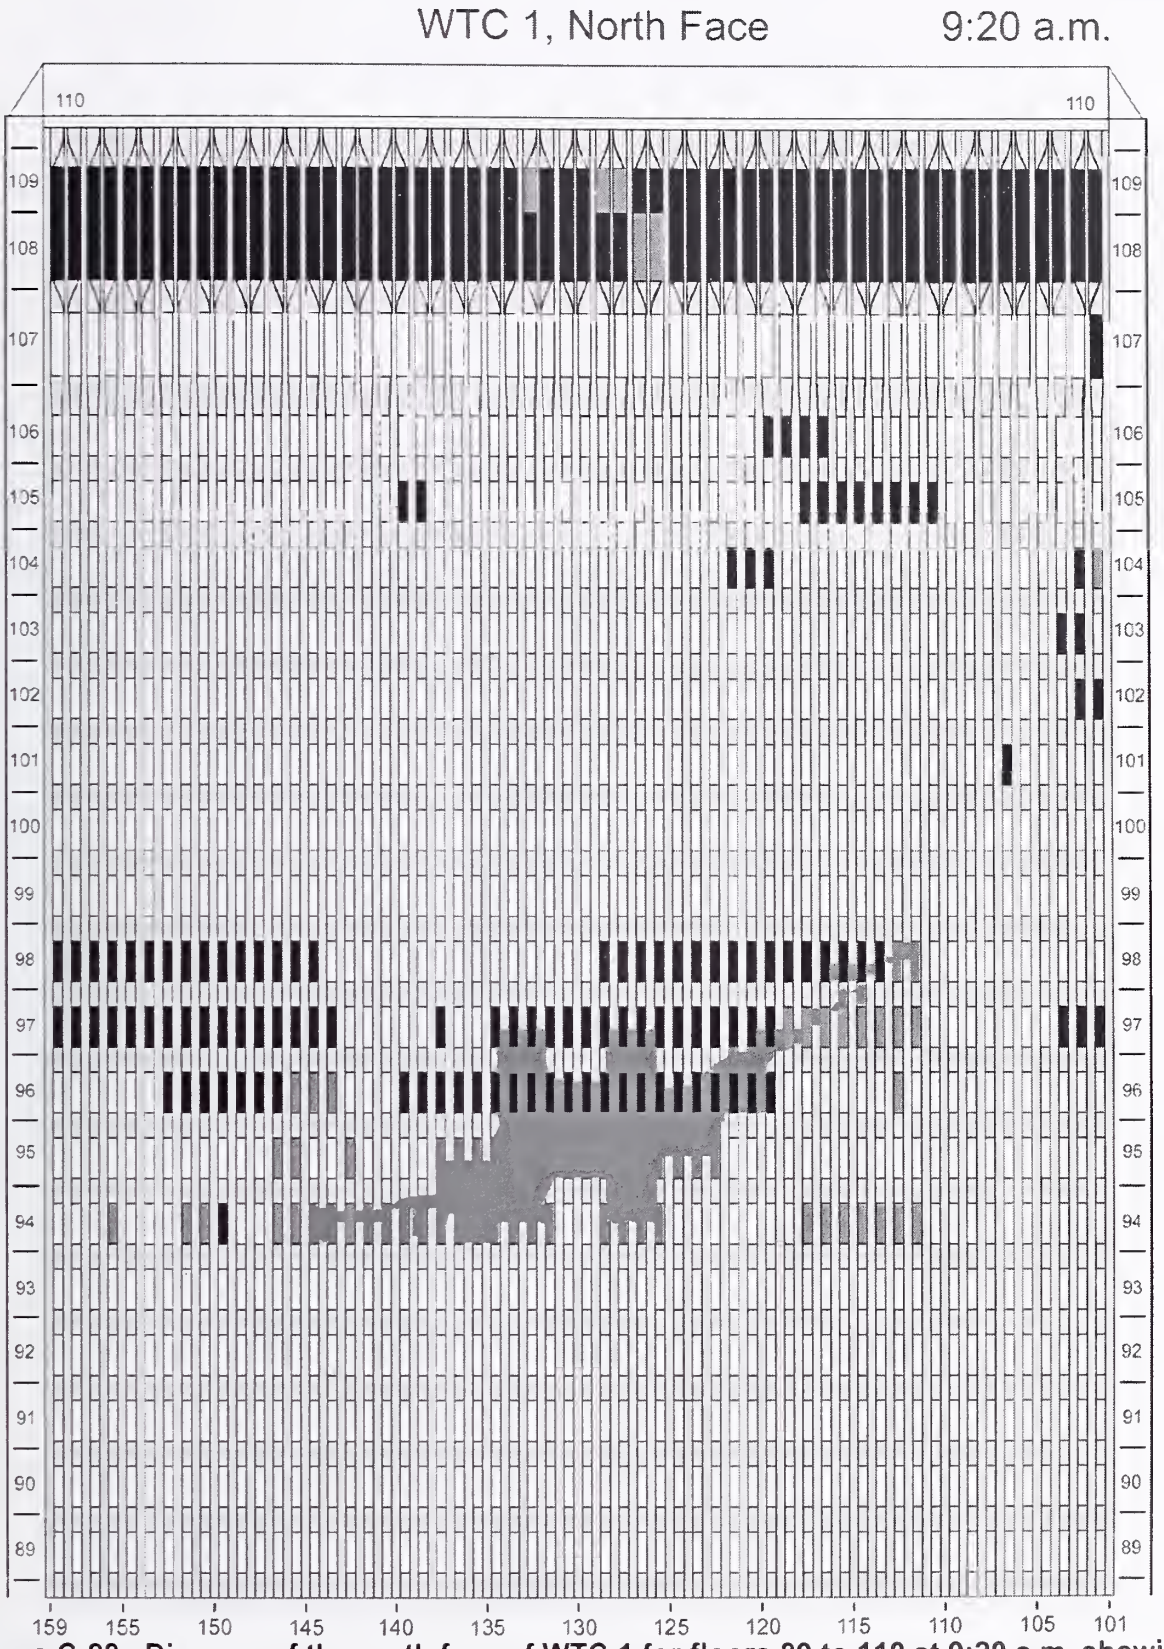
Figure C-28. Diagram of the north face of WTC 1 for floors 89 to 110 at 9:20 a.m. showing windows where smoke was observed and those that were hidden from view.

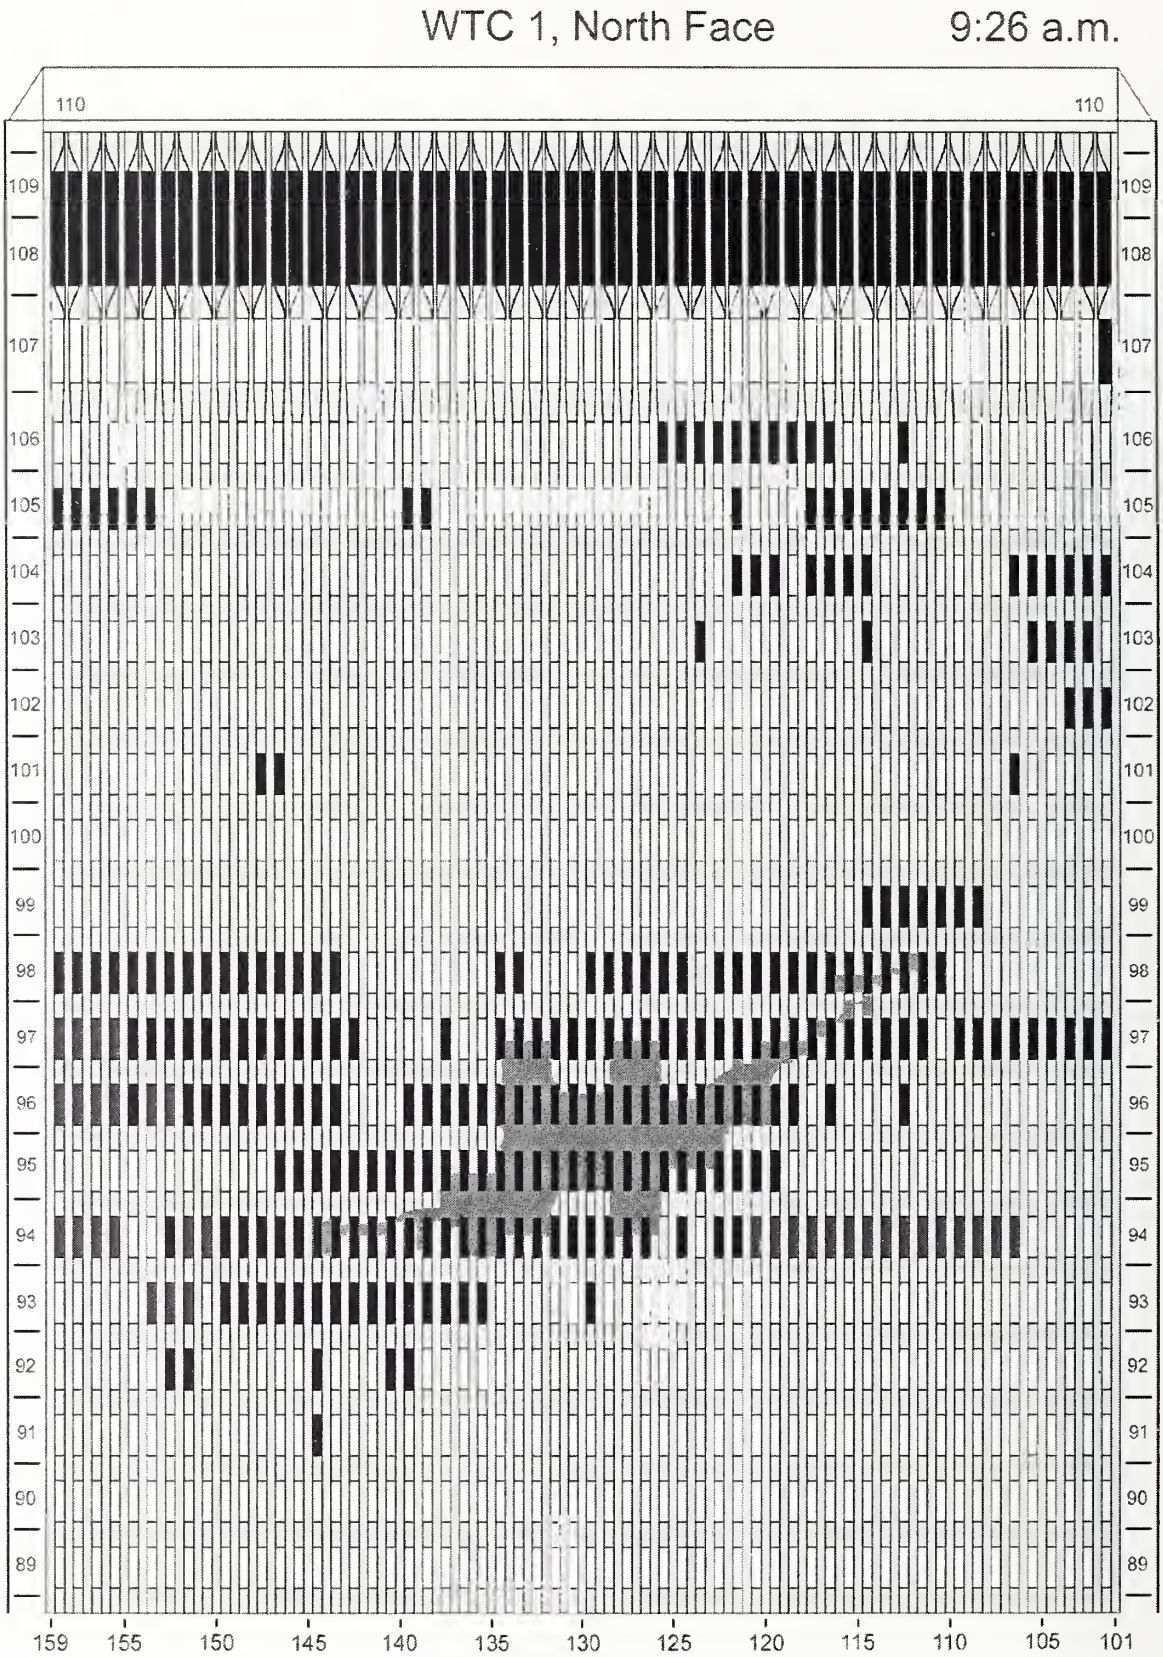
Figure C-29. Diagram of the north face of WTC 1 for floors 89 to 110 at 9:26 a.m. showing the condition of windows and locations of fires.

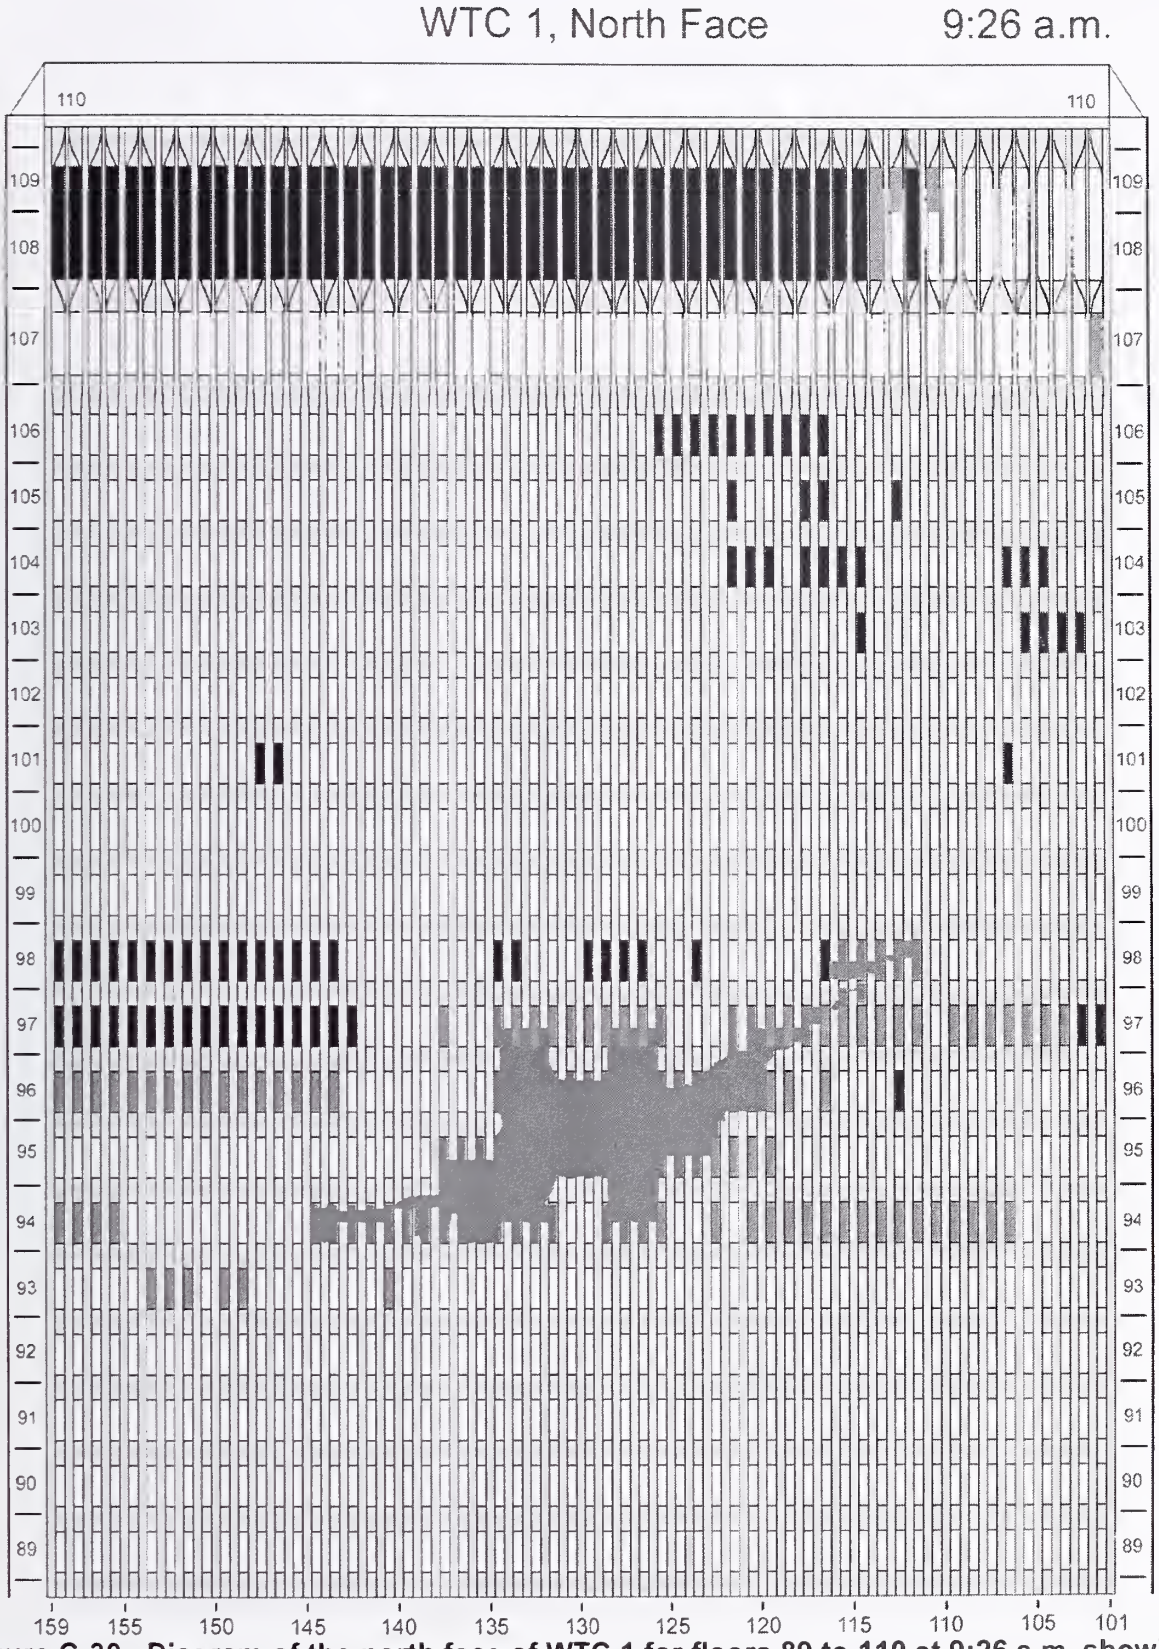
Figure C-30. Diagram of the north face of WTC 1 for floors 89 to 110 at 9:26 a.m. showing windows where smoke was observed and those that were hidden from view.

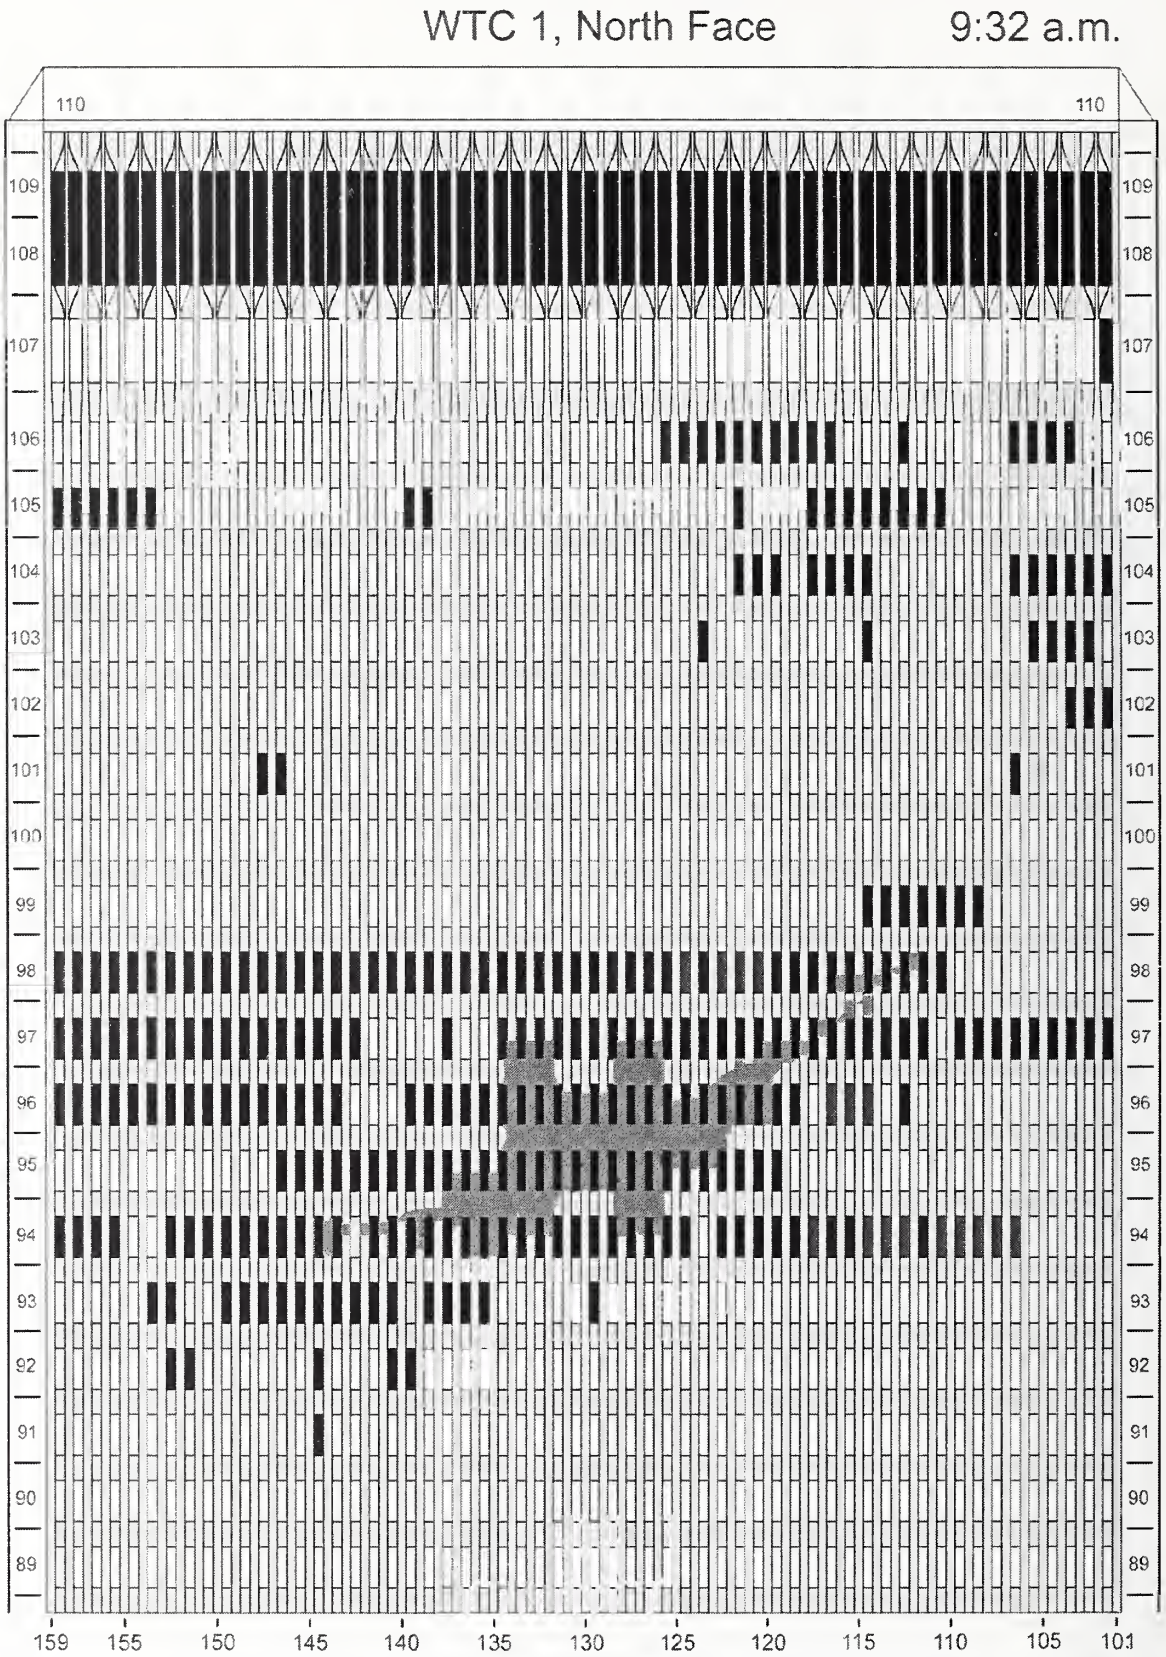
Figure C-31. Diagram of the north face of WTC 1 for floors 89 to 110 at 9:32 a.m. showing the condition of windows and locations of fires.

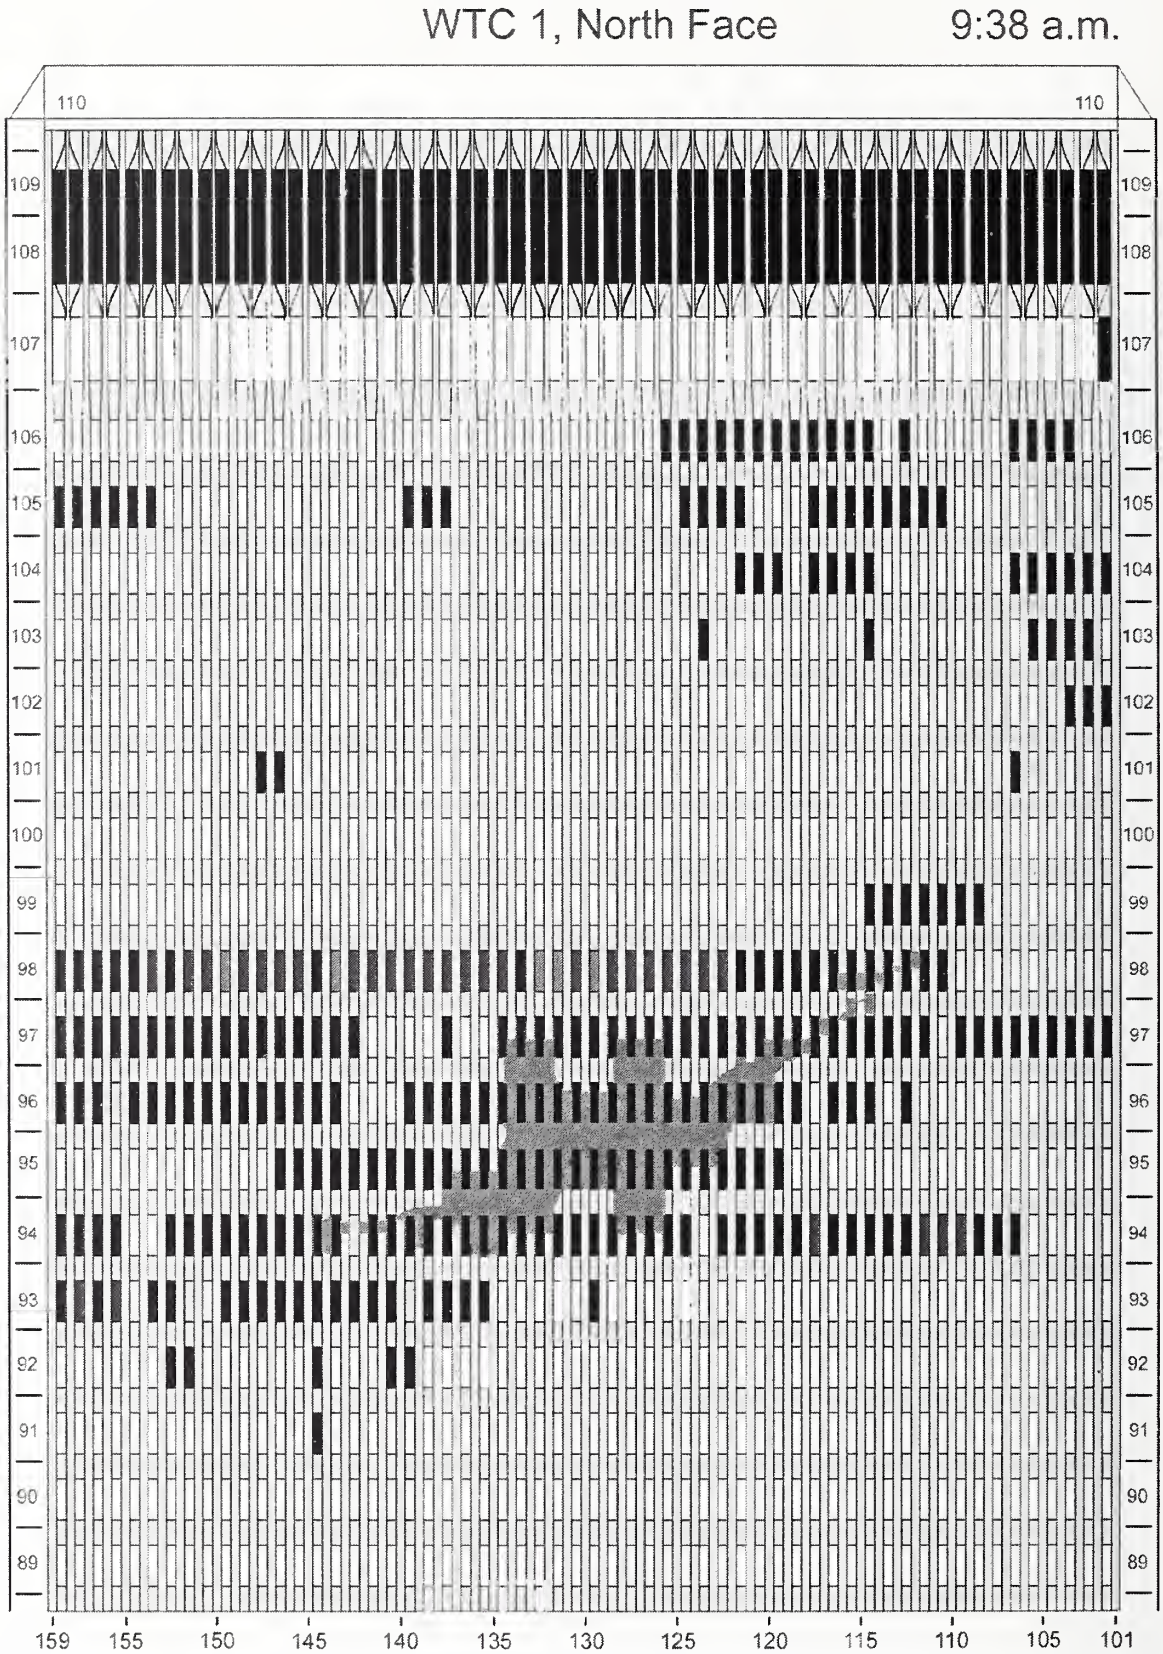
Figure C-33. Diagram of the north face of WTC 1 for floors 89 to 110 at 9:38 a.m. showing the condition of windows and locations of fires.

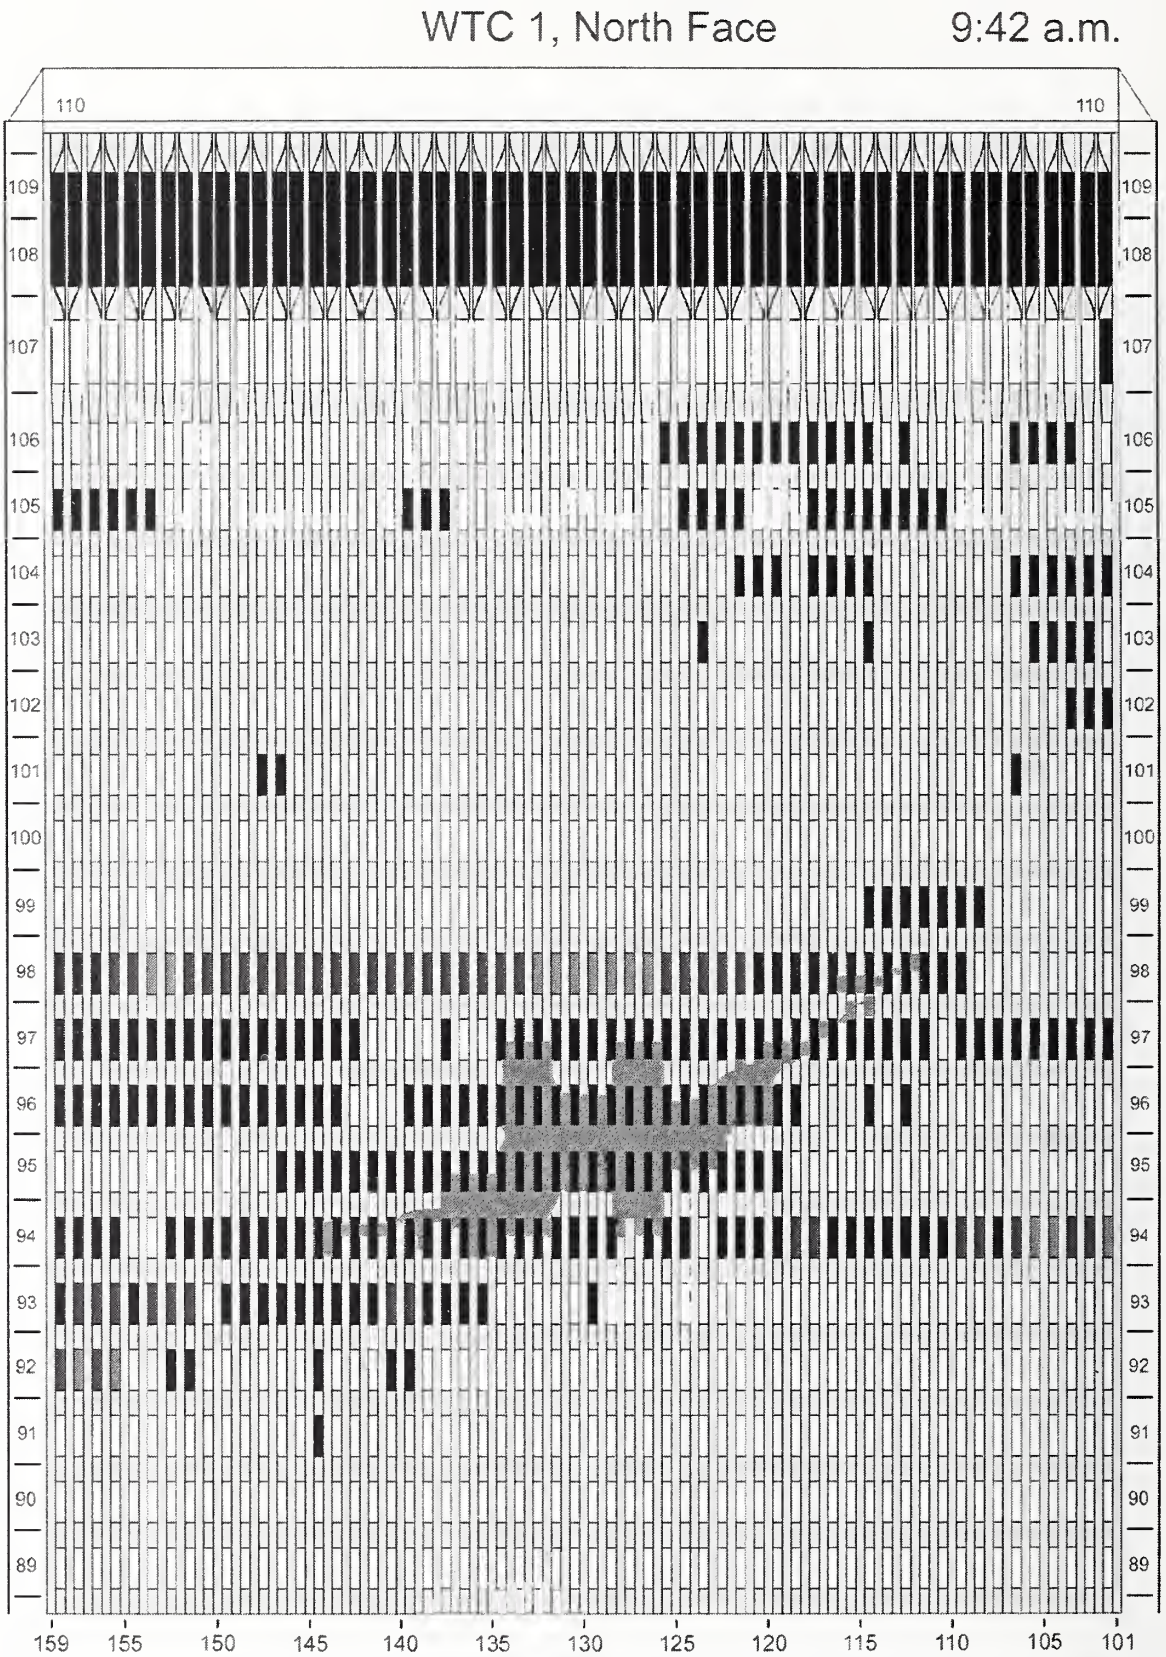
Figure C-35. Diagram of the north face of WTC 1 for floors 89 to 110 at 9:42 a.m. showing the condition of windows and locations of fires.

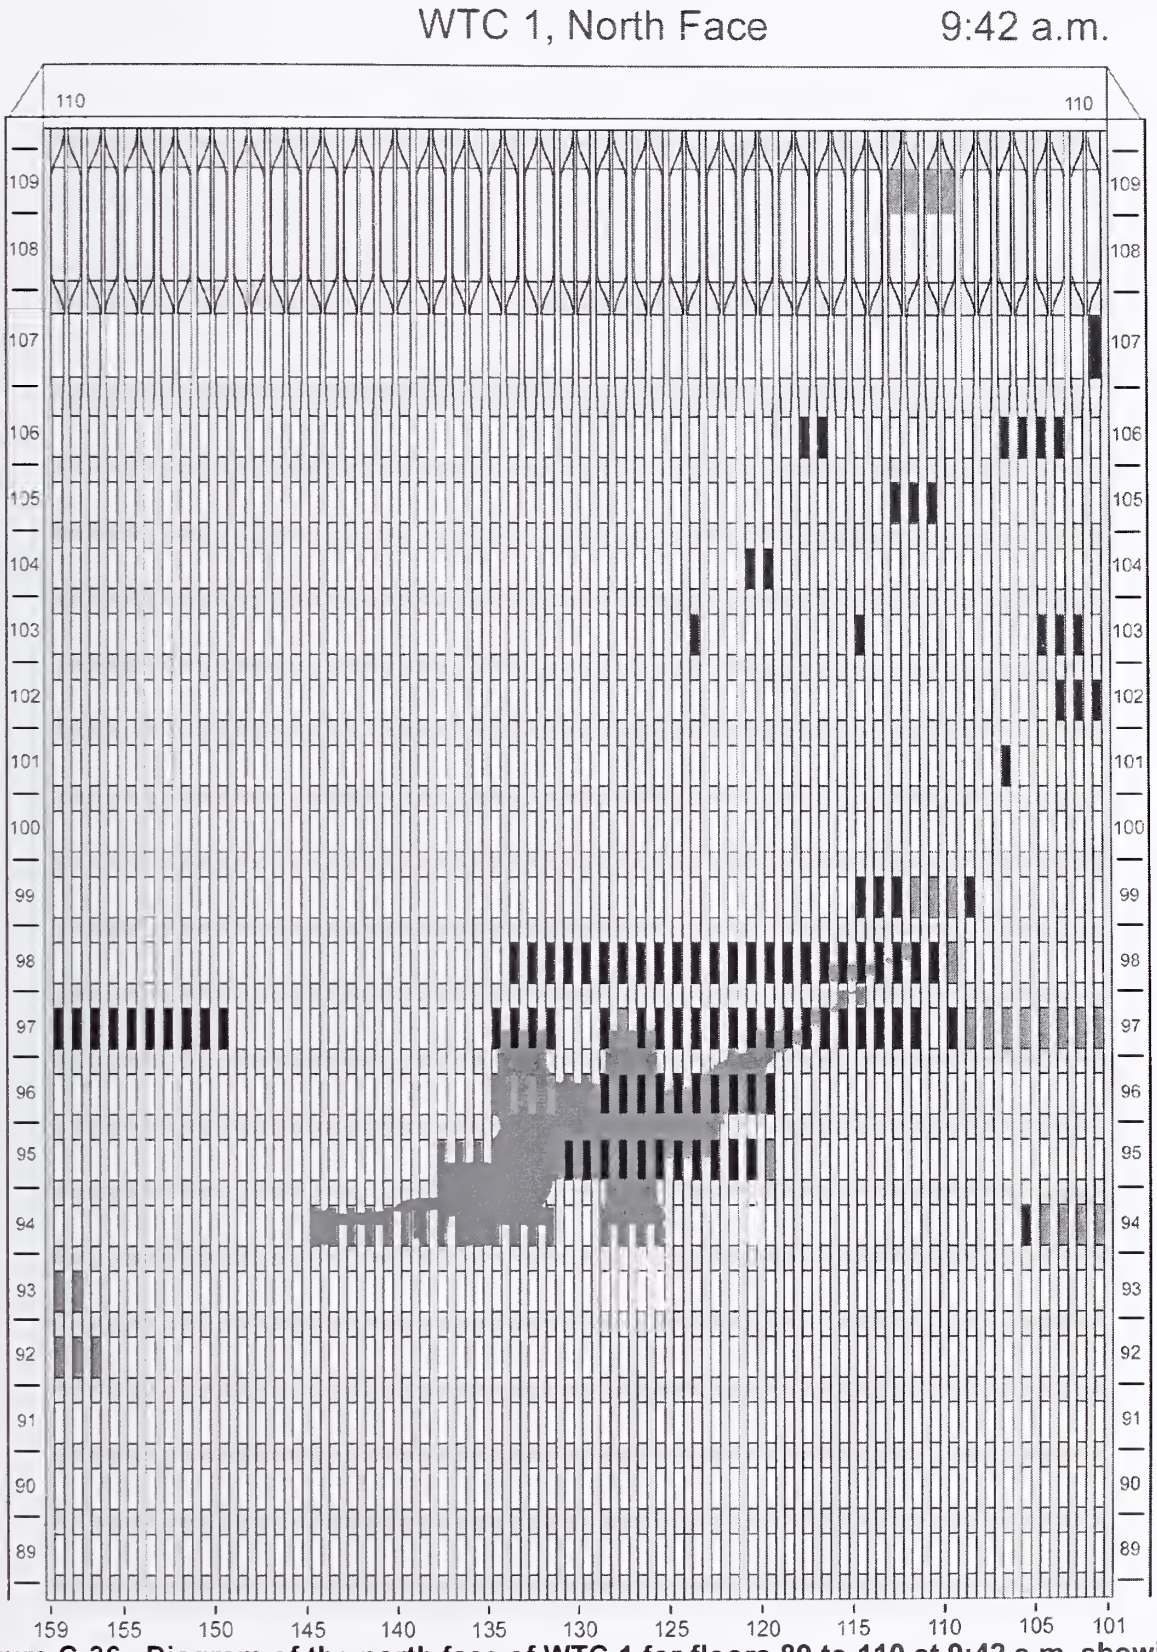
Figure C-36. Diagram of the north face of WTC 1 for floors 89 to 110 at 9:42 a.m. showing windows where smoke was observed and those that were hidden from view.

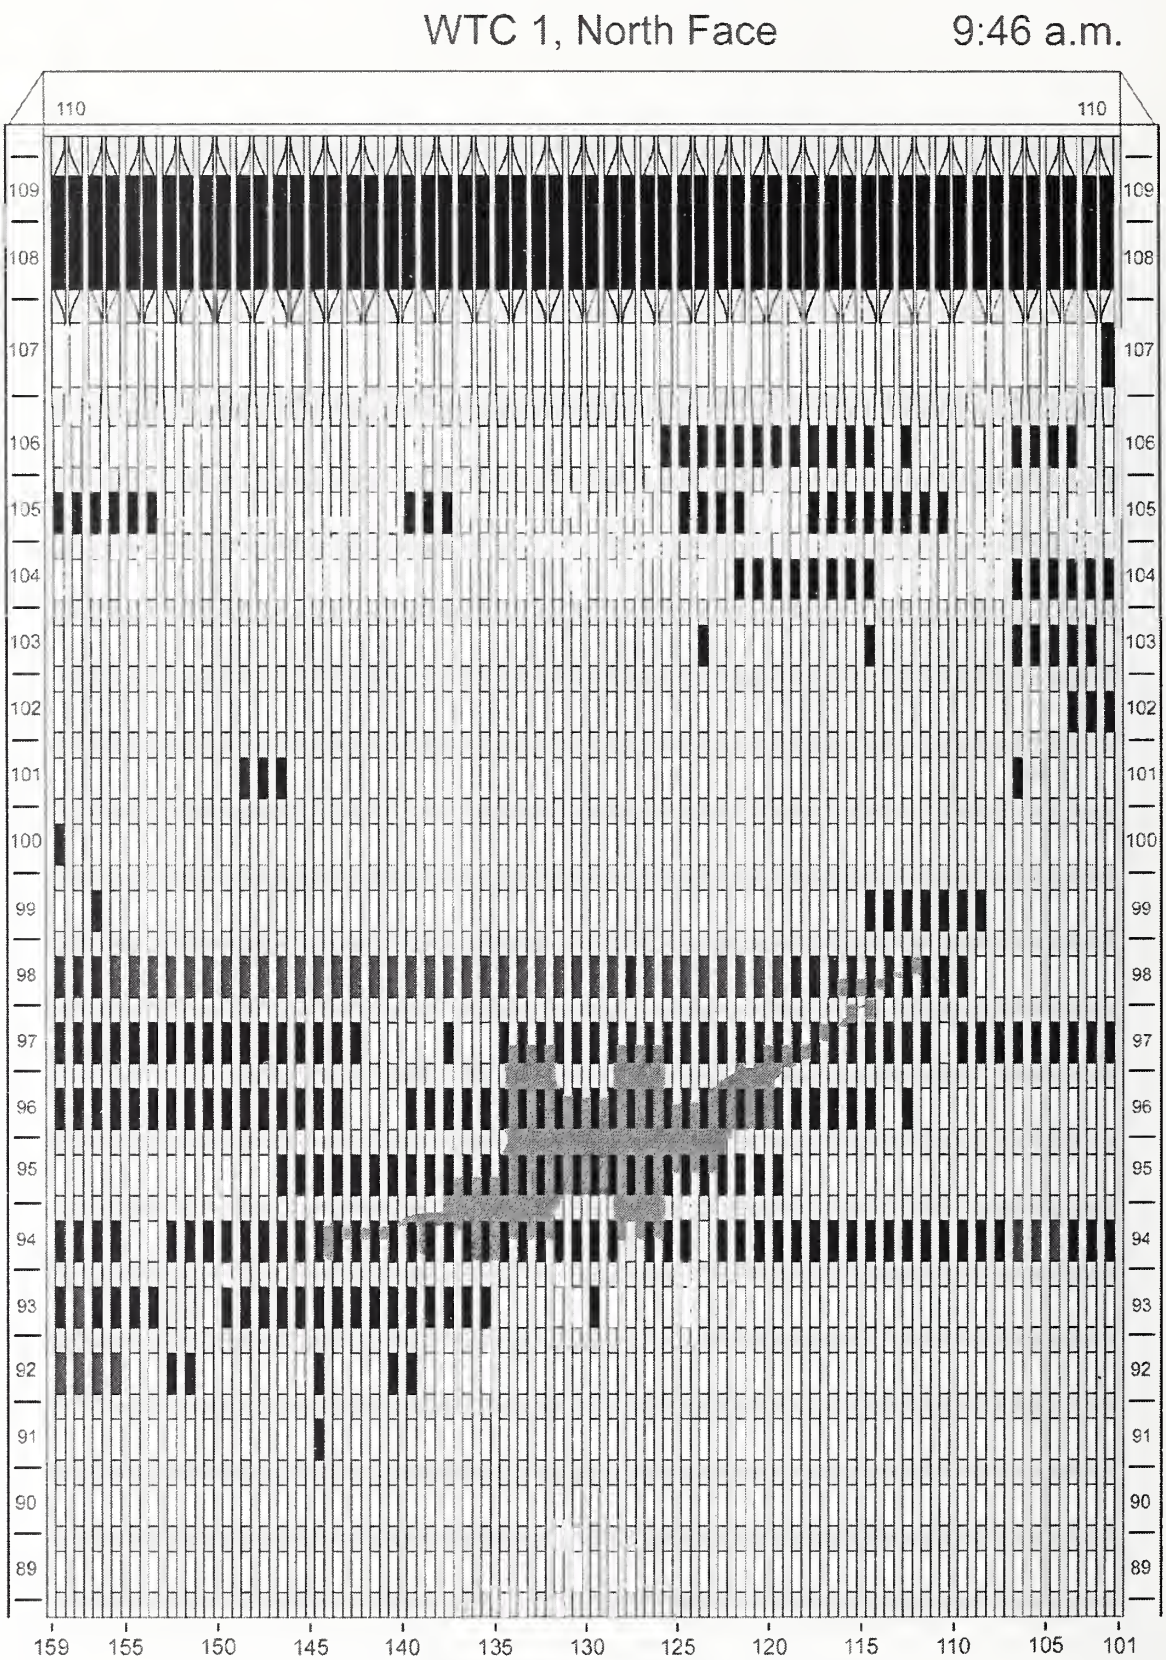
Figure C-37. Diagram of the north face of WTC 1 for floors 89 to 110 at 9:46 a.m. showing the condition of windows and locations of fires.

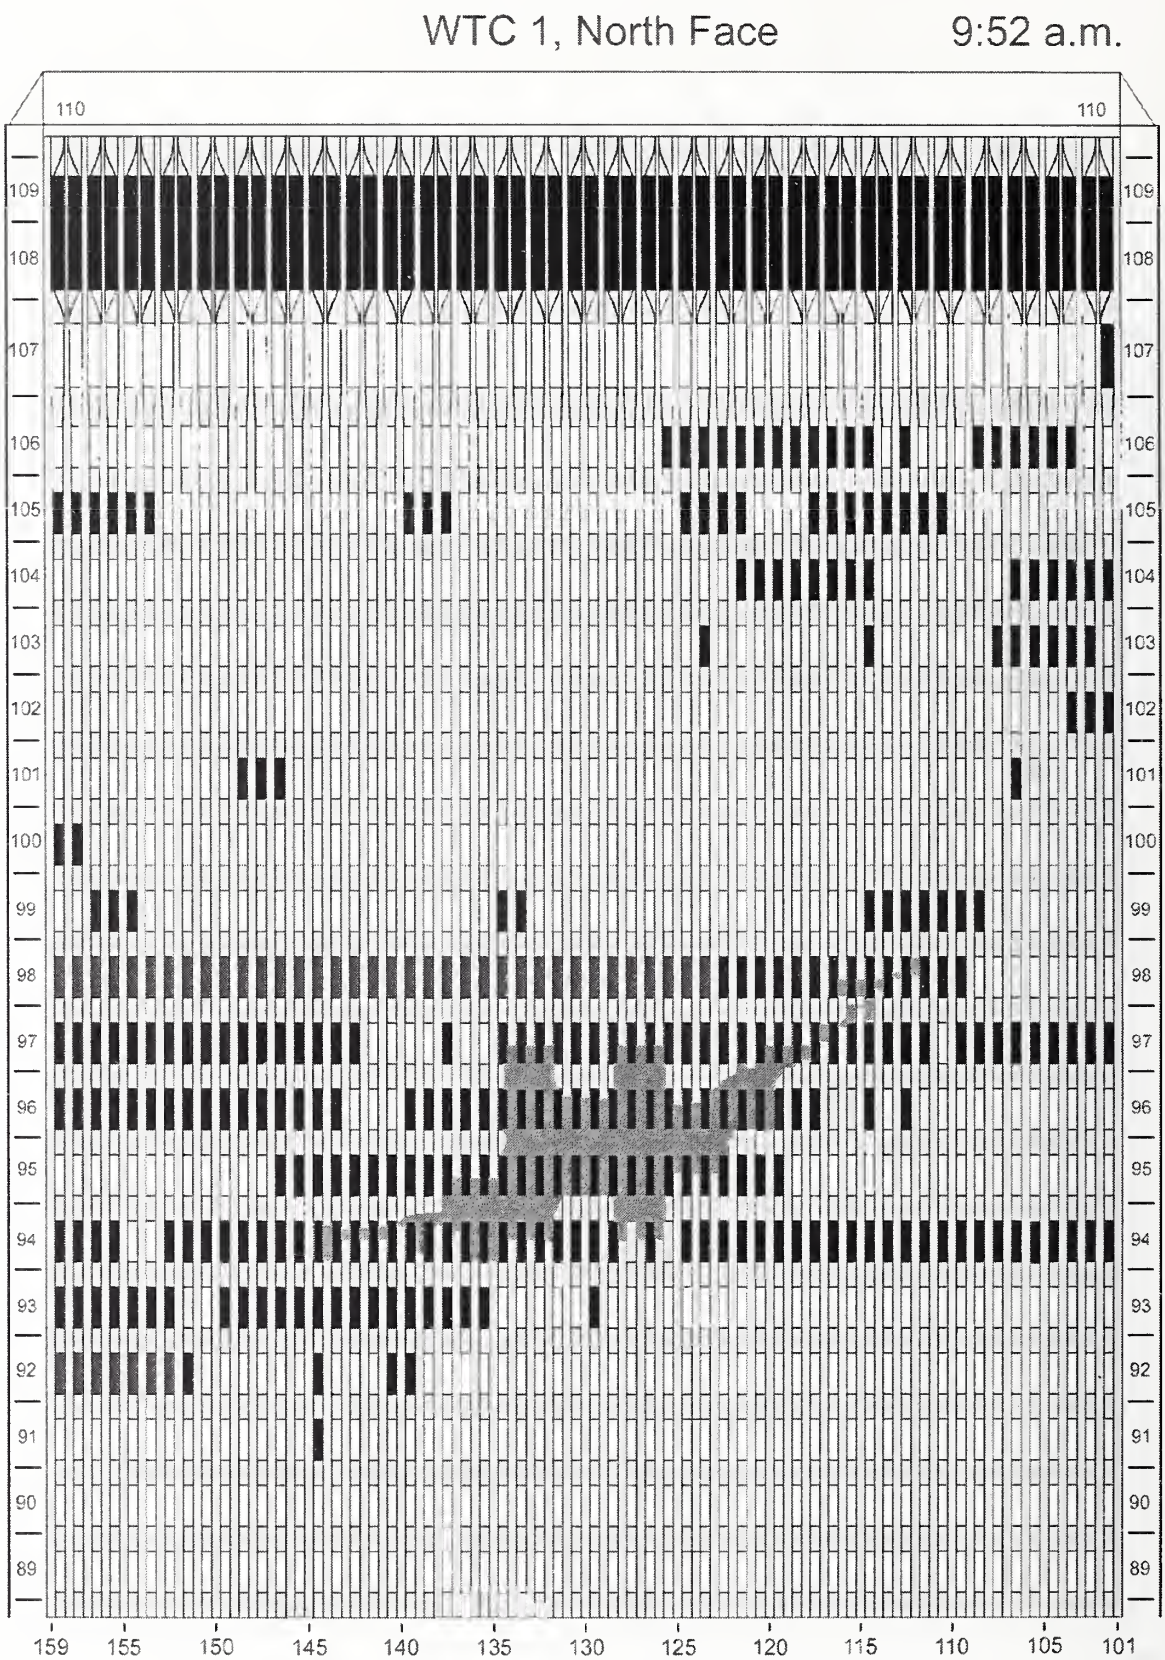
Figure C-39. Diagram of the north face of WTC 1 for floors 89 to 110 at 9:52 a.m. showing the condition of windows and locations of fires.

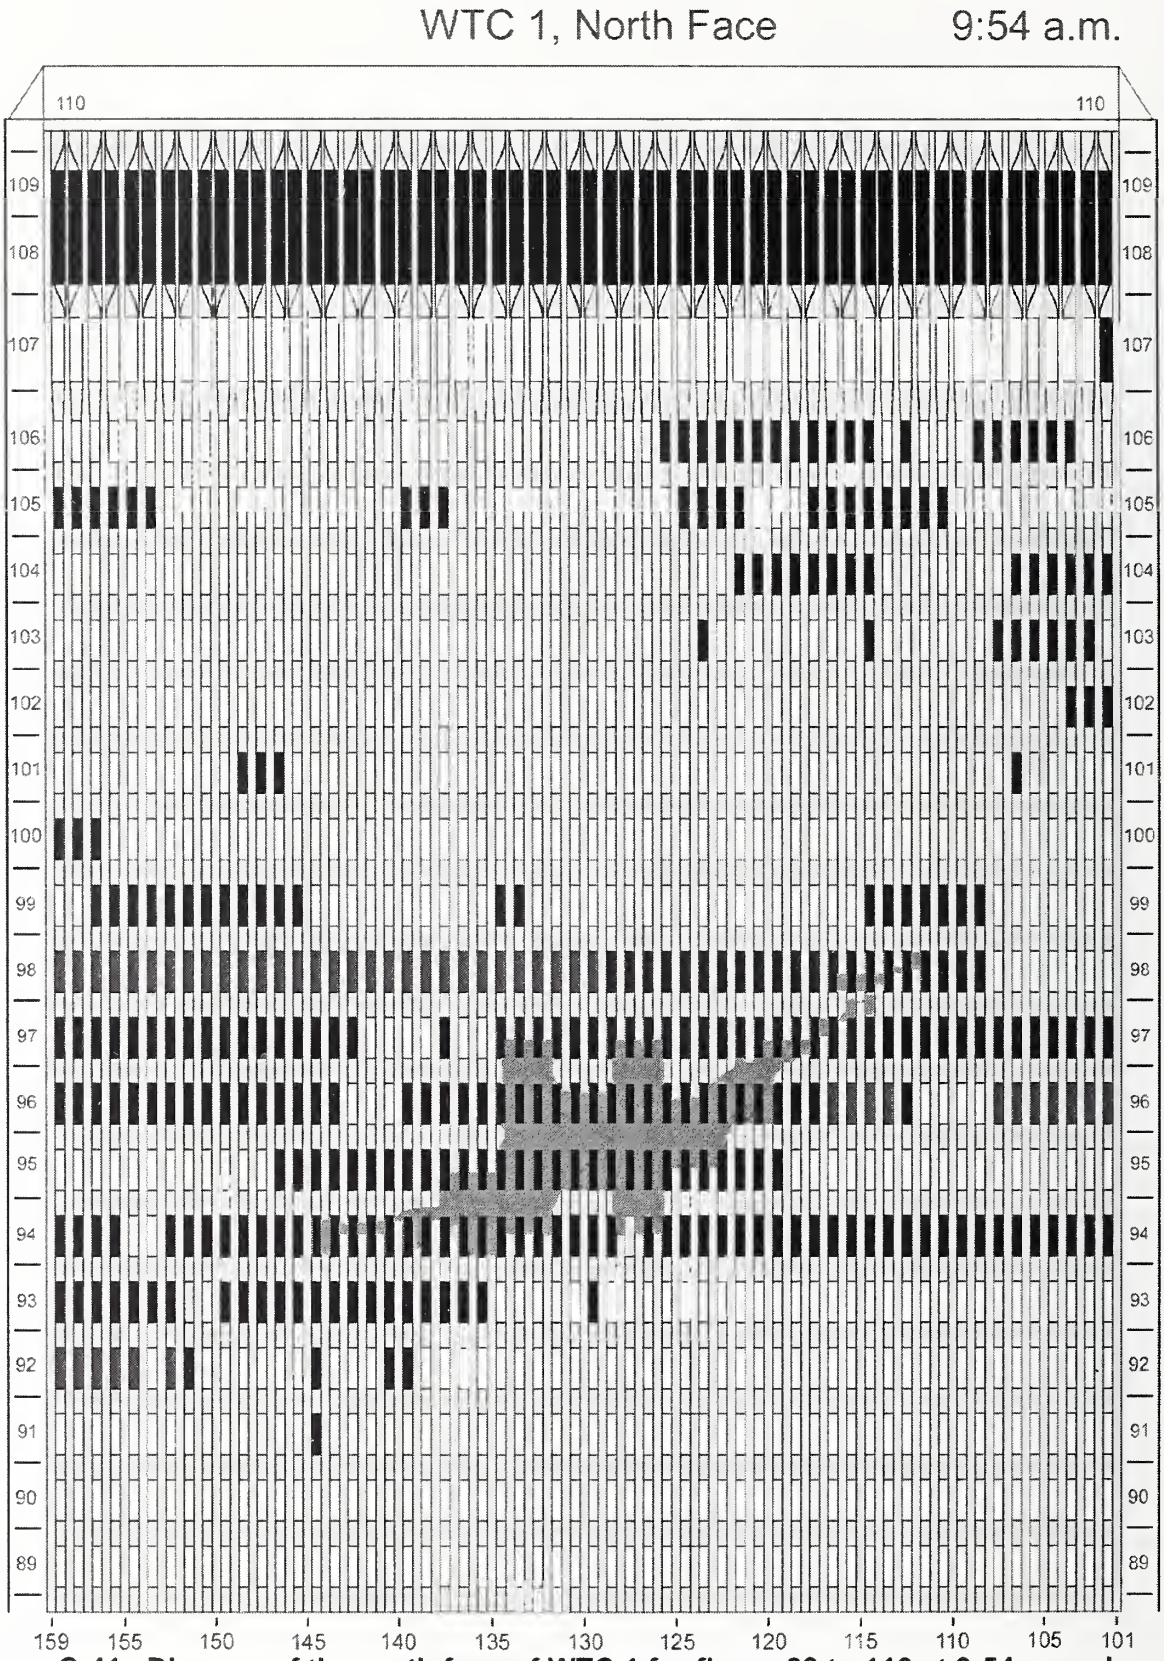
Figure C-41. Diagram of the north face of WTC 1 for floors 89 to 110 at 9:54 a.m. showing the condition of windows and locations of fires.

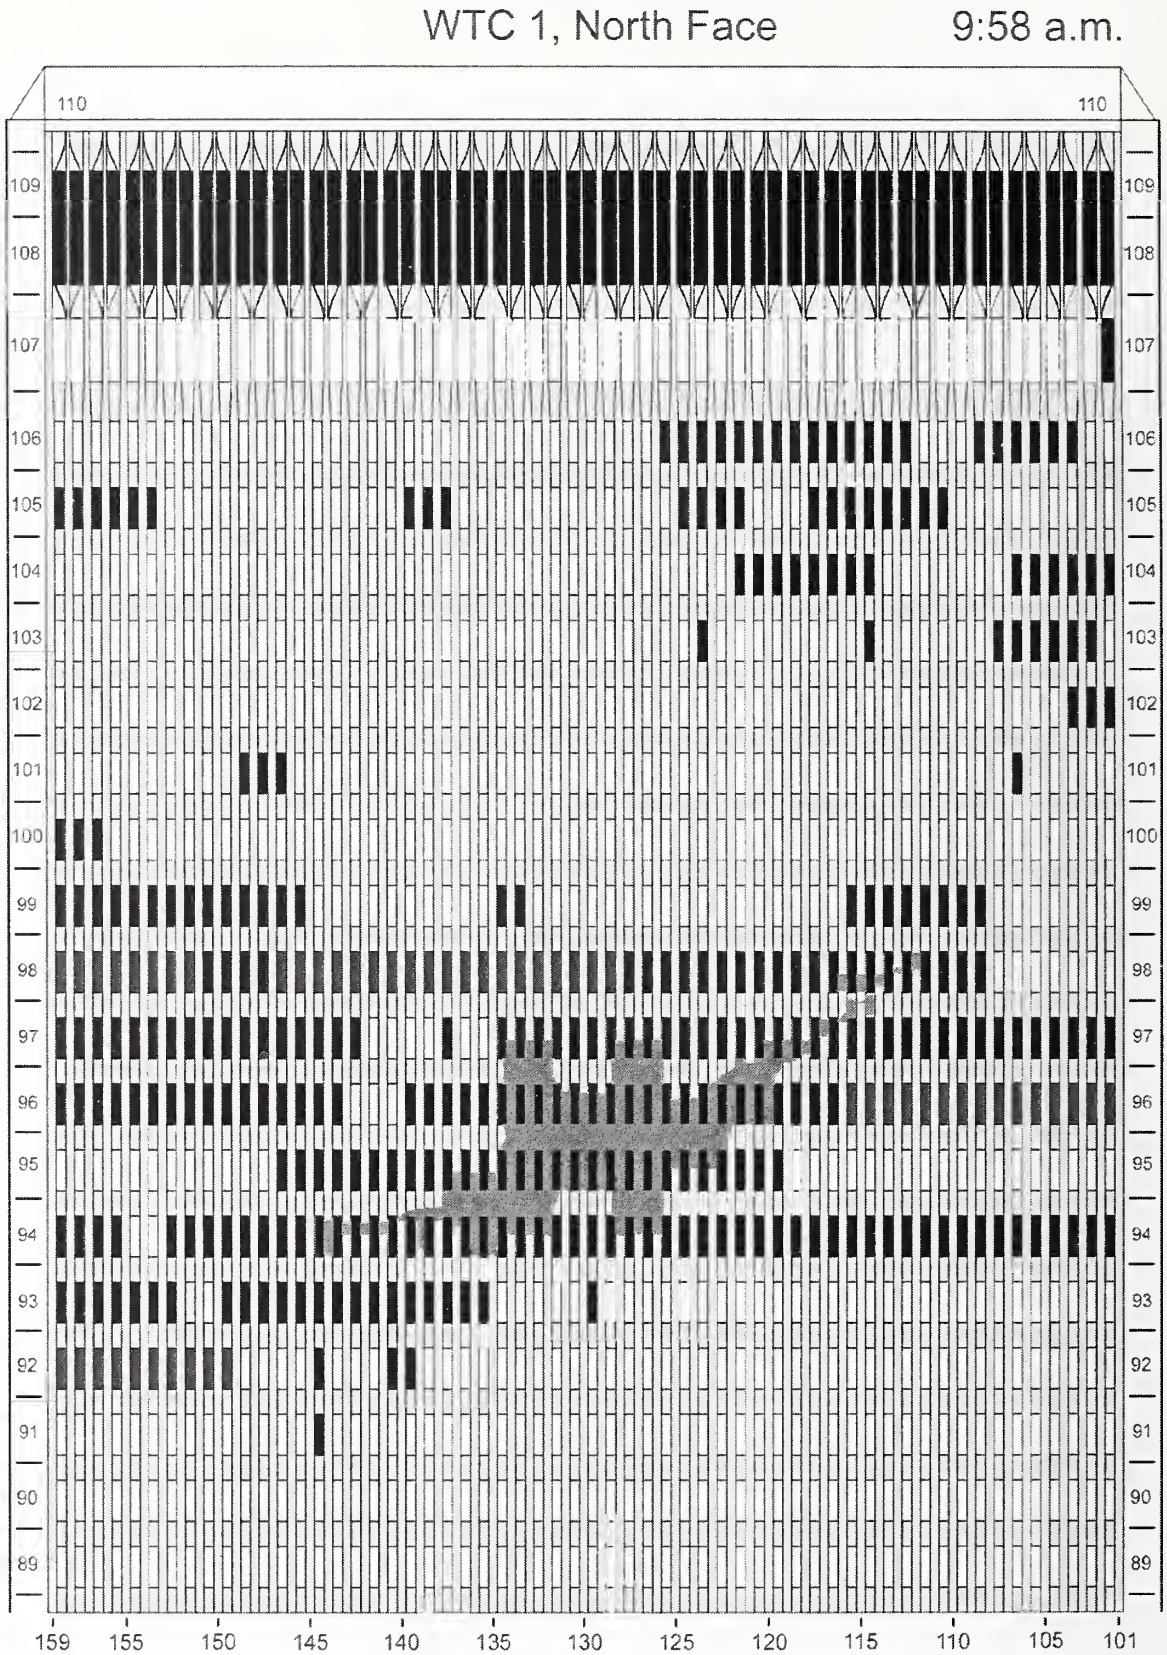
Figure C-43. Diagram of the north face of WTC 1 for floors 89 to 110 at 9:58 a.m. showing the condition of windows and locations of fires.
